# How do you remove and prevent flash rust on stainless steel?

One of the problems of stainless steels is that they are susceptible to rust if they do not have correct maintenance. In this article, some common rust problems are dealt with, and it is shown how the rust can be removed by using a simple kit consisting of two liquid agents and a special sponge.

*N. W. Buijs – Metallurgist – Innomet b.v.*

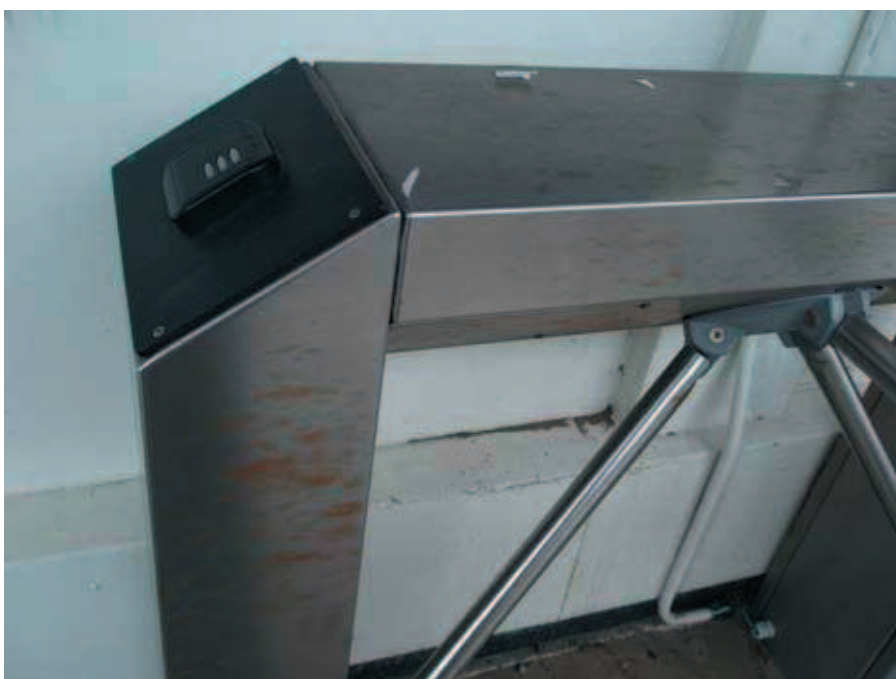
Fig. 2. RVS 316 access gate corroded by aerosols.

Local rust spots can also develop due to aerosols, for example, and this primarily occurs in coastal areas. Aerosols are small droplets of seawater that are carried from the sea by the wind and which evaporate during their flight leading to a further increase in salt and chloride concentrations. This forms a greater corrosive load for stainless steel than normal seawater. The result is local corrosion that can also even lead to pitting corrosion at times. The effect of this action can regularly be seen on stainless steel parts on or near the shore in particular. In Fig. 2 you can

see an access gate made from stainless steel 316 that is situated near to the coast. Rust spots, which in this case are also known as tea stains, can clearly be seen.

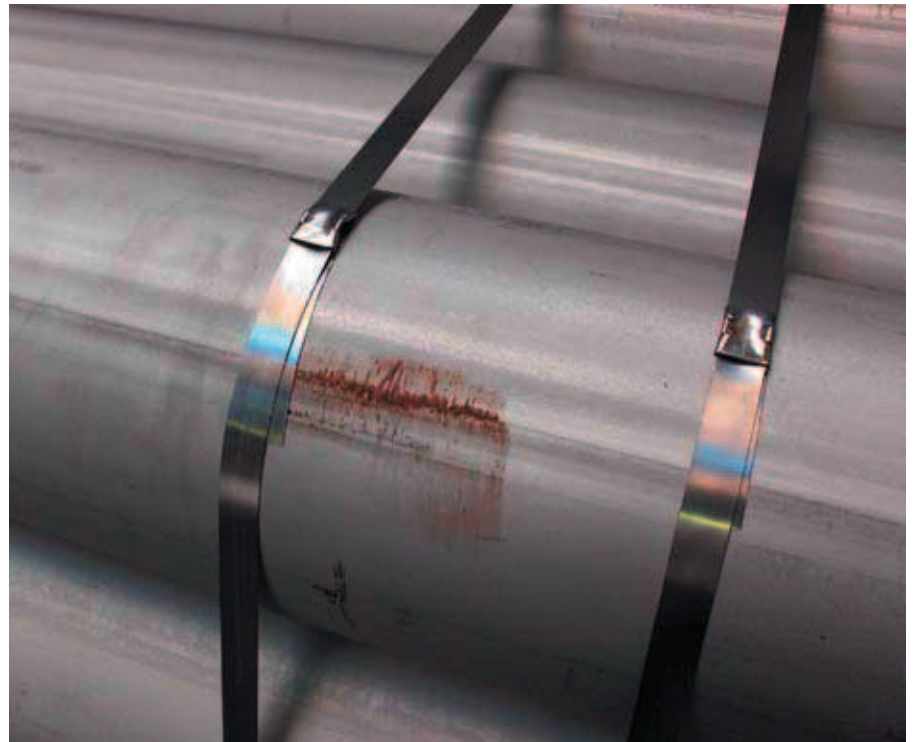
Fig. 3. Contamination by a steel object such as the fork of a forklift truck.

Another common reason for contamination corrosion is the contact between carbon steel and stainless steel due, for example, to steel forks of forklift trucks, nails on pallets, contact with Stelcon plates, steel tools, steel transport rollers etc. An example of this can be seen in Fig. 3. Corrosion prod-

ucts can clearly be seen seeping out of the ‘wound’, causing further contamination to the surface. If this damage is not removed then the corrosion will quickly continue in this area until the material is bored through locally as it were. The speed with which it happens is due to the fact that contact occurs between a small anode and a large cathode.

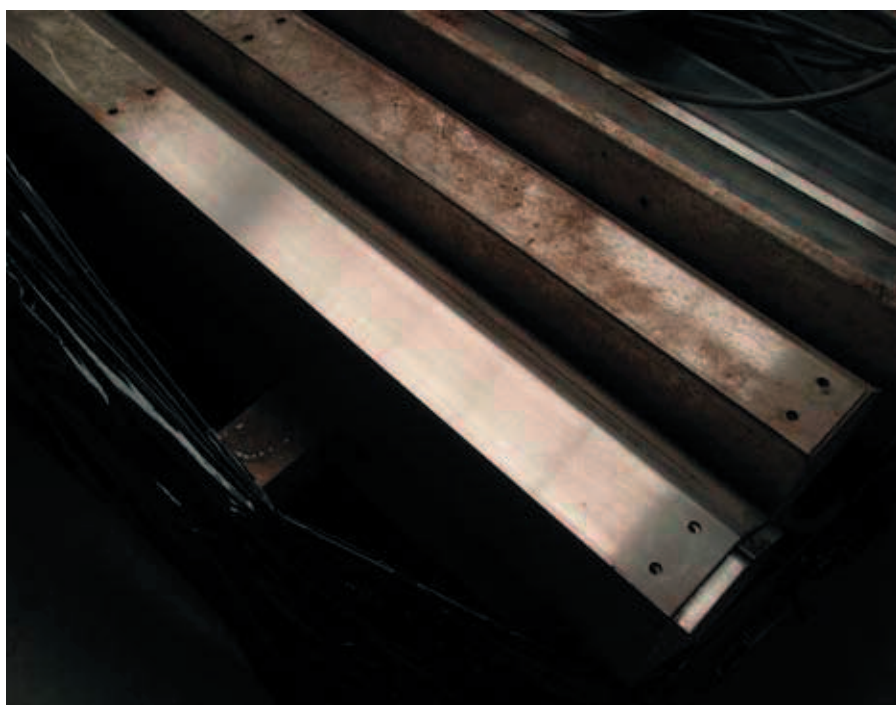
Fig. 4. Contamination corrosion on 316L light fittings (the bottom fitting has partially been treated with the organic acid Innosoft B570).

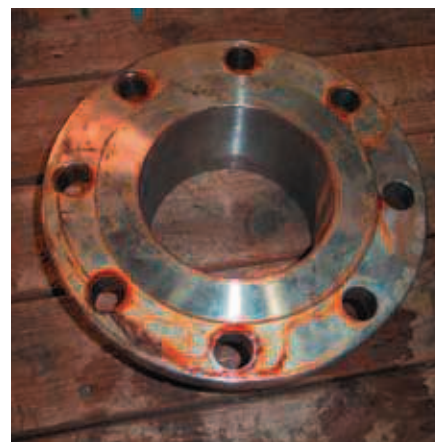
Fig. 5. RVS 304 flange contaminated by ferruginous water.

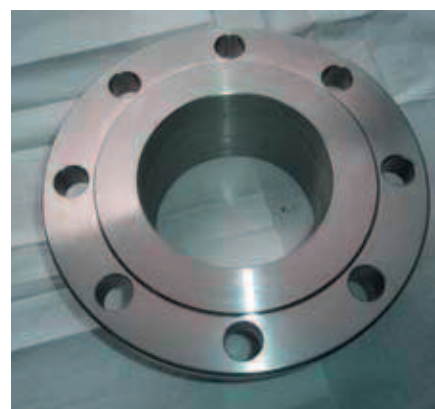
Fig. 6. The same flange as in Figure 5 but cleaned with Innosoft B570 and coated with a nanolayer.
